HOUSTON, TEXAS

FLORIDA PANHANDLE

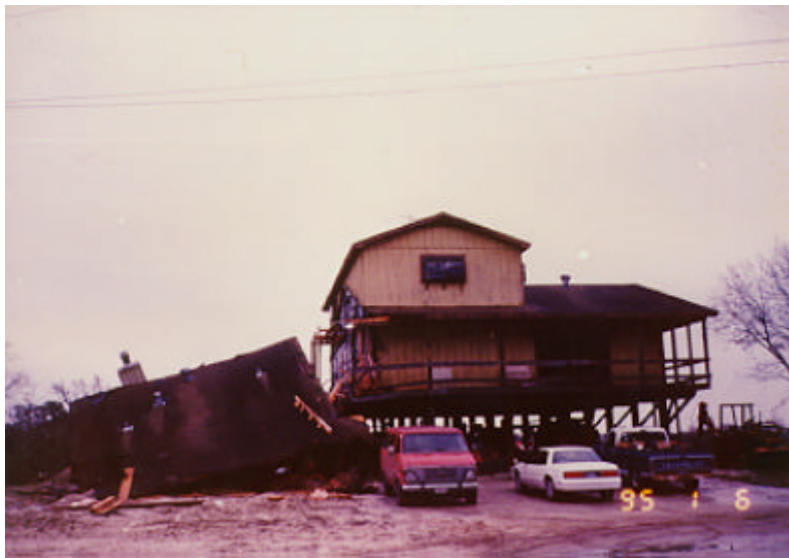
STRUCTURE 59. This single-family home was constructed in 1983 on 10-inch by 10-inch wooden posts spaced about 10 feet apart. The posts varied in embedment depth below grade from 4 feet to 8 feet with no concrete in the post hole. The building's first floor was elevated about 10 feet above grade. The building was located about 30 feet from the bank of the San Jacinto River. The flood depth was about 4 feet around the structure. A concrete slab-on-grade was in place beneath the structure. A closed-in utility room was in place in the lower area between the slab-on-grade and the first floor of the structure. This enclosure was located near the "upstream" corner of the structure. Failure occurred at the upstream end of the structure due to scour to depths below post embedment.

Lesson. This structure was exposed to extreme high velocities. Structure failure occurred because of four basic reasons. First, the enclosed lower area utility room created even higher localized velocities than already present as the floodwater flowed around the obstruction. Second, the enclosed area was near the "upstream" corner of the structure so the localized velocity increase occurred near the slab edge where scour could occur beneath the slab. Third, perimeter footings were not in place under the slab-on-grade to prevent scour beneath the slab. Fourth, the post embedment depth was not deeper than the scour depth. These factors combined to create a situation conducive to massive scour and failure. The eastern portion of the structure, which did not have an enclosed area, functioned successfully.

Looking at the collapsed portion of the structure. The collapsed portion is at the left.
The river is behind the structure

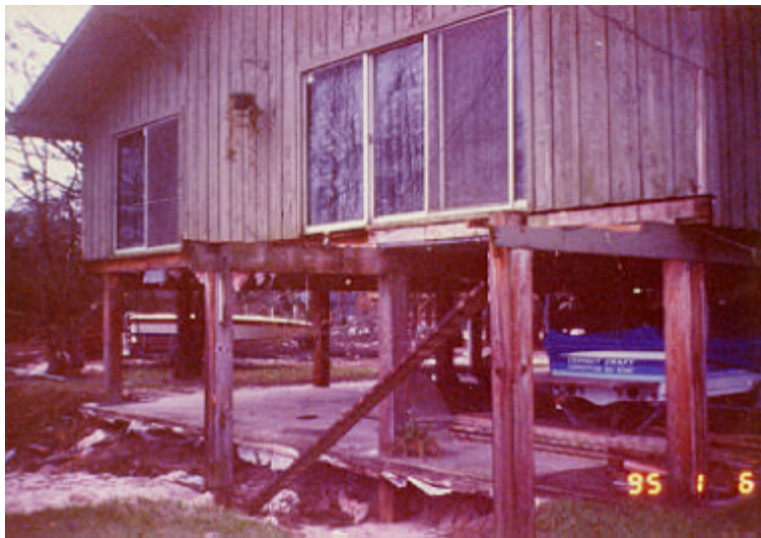
STRUCTURE 60. This structure was a single-family home with its first floor elevated about 8 feet above a concrete slab-on-grade. This home sat directly east of Structure 59 and about 30 feet from the San Jacinto River. It was elevated on 10-inch by 10-inch wooden posts spaced from 12 to 16 feet apart. The entire area beneath the first floor was open for unobstructed floodflow. This home was not damaged to any great extent. The only visual damage was a small amount of scour along the north edge of the slab.

Lesson. This flood proofing system functioned very well. This appears to be due to the lack of a localized velocity-increasing mechanism, such as a lower enclosed area, that would create a situation conducive to large amounts of scour. This structure should be retrofitted with perimeter footings around the slab-on-grade embedded to below scour depth to prevent the amount of scour that did occur.

Looking away from the river at the structure. Note the area beneath the structure is completely open.

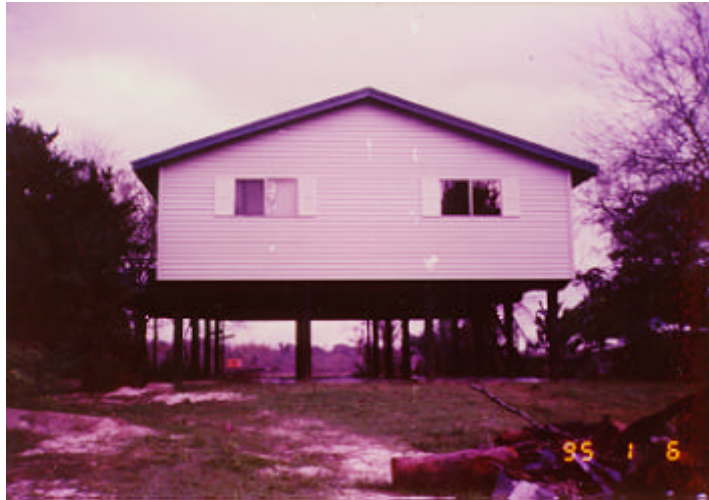
STRUCTURE 62. This single-family home was elevated on 8-inch by 8-inch wooden posts about 10 to 13 feet apart. The first floor was about 9 feet above the concrete slab-on-grade. The home was about 40 feet from the San Jacinto River. No damage occurred to the structure. No evidence of any scour was present.

Lesson. This flood proofing system worked well. No scour was evident, probably because of the "shield" effect of a row of trees and brush to the left (upstream) side of the structure. These trees apparently provided protection from the high velocities so scour did not attack even the slab-on-grade. The lack of an enclosed obstruction in the lower area prevented the creation of high localized scour-producing velocities. Scour was evident to the left of the row of trees.

Looking toward the river at the structure. Note the trees on the left that apparently protect this structure.
Note, also the lack of any obstruction beneath the structure.

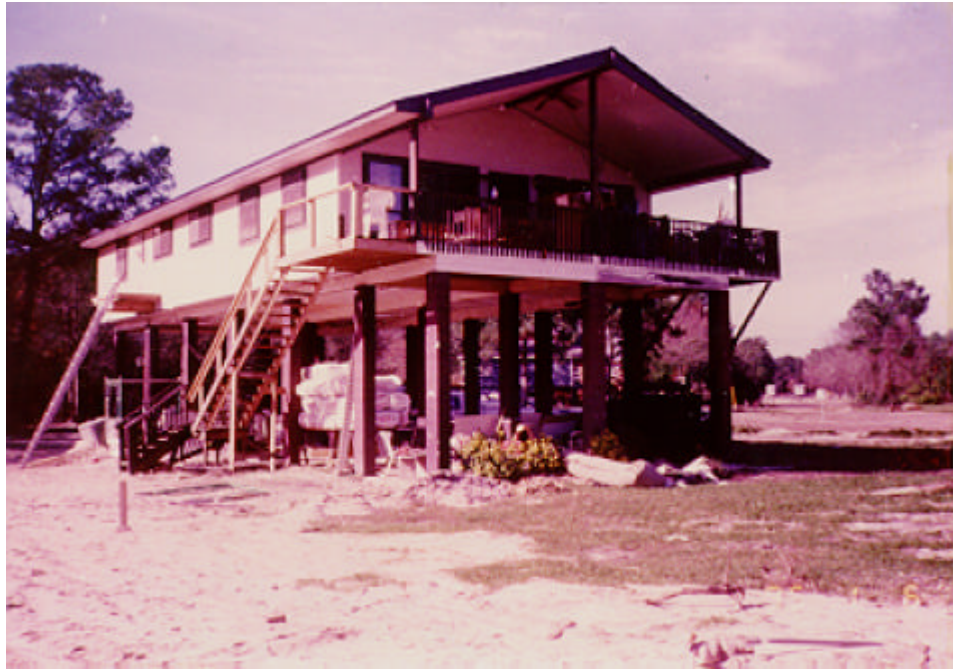
STRUCTURE 64. This single-family home was elevated 13 feet 5 inches above grade on columns made of 12-inch by 16-inch concrete block. The columns were grouted with concrete and contained six rebars each running the full column length and tying into the foundation. The foundation was a "floating concrete slab" comprised of 18-inch-deep by 12-inch-wide reinforced concrete beams buried just below grade horizontally with a 6-inch concrete slab on top of the beams at grade. The columns were about 11 to 12 feet apart. The structure was about 150 feet from the San Jacinto River. Debris accumulated at the northeast corner of the structure. This debris obstruction, coupled with high-velocity floodwater, caused hydrodynamic force to slightly tip this floating structure. Considerable scour occurred around the debris accumulation.

Lesson. This structure received relatively little flood-related damage during this event. The home was realigned and the scoured area filled. Even with this "success," this flood proofing system should not be promoted. The risk to this structure is great for two reasons--both related to debris accumulation. First, severe debris accumulation, coupled with hydrodynamic force, could tip over the structure. Second, scour could severely undermine this structure's foundation because of debris accumulation, also resulting in the structure tipping.

Looking NW at the structure. The San Jacinto River is at far right outside of the photograph.

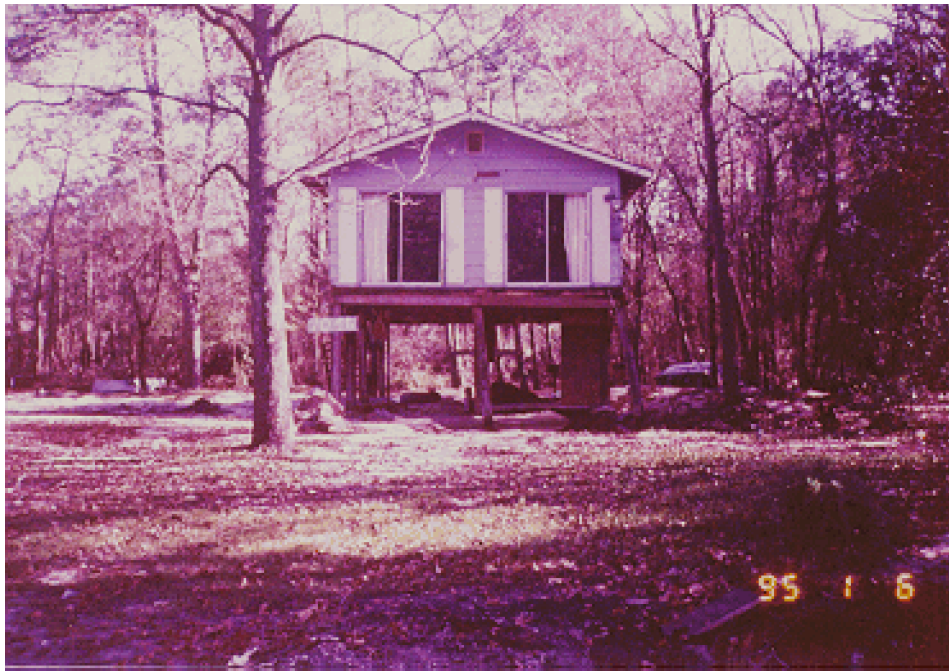
STRUCTURE 65. This single-family home was elevated on wooden posts. It was located a considerable distance from the San Jacinto River. Damage occurred to this structure because of localized scour and shallow post embedment depth coupled with concrete placement around the post only at the surface. A portion of the lower area was enclosed, creating a condition for high localized velocities and scour.

Lesson. Damage occurred with this system because of the enclosed lower area, which created high localized velocities and scour, and the extremely shallow post embedment depth. If the posts had been embedded to a greater depth and placed in concrete and the enclosed area had not been present, this structure would probably have sustained no damage.

Looking at the structure.

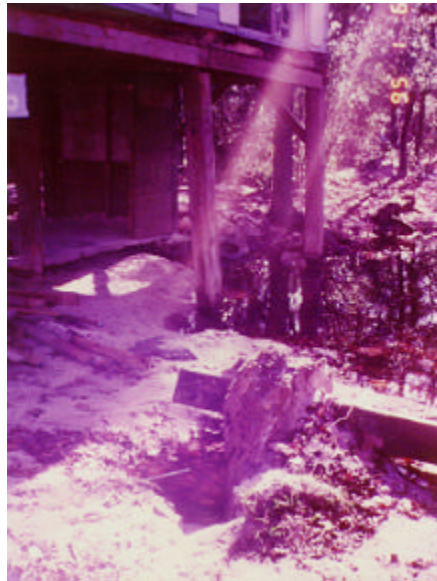
Looking at the structure's shallow post embedment depth.

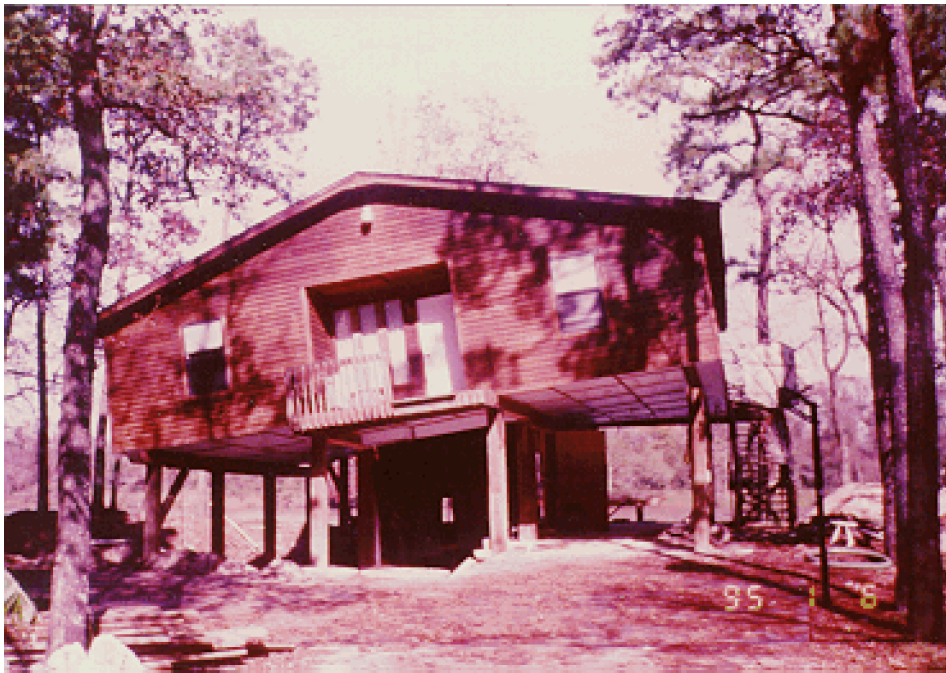
STRUCTURE 66. This single-family house was elevated about 9½ feet from first floor to concrete slab-on-grade by 10-inch by 10-inch wooden posts located from 10 to 12 feet apart. The posts were embedded from 6 feet to 10 feet below grade without concrete. Floodwater depth was about 6 feet. An enclosed utility area was located in the central portion of the lower area. The structure was located about 40 feet from the San Jacinto River. Failure occurred due to scour.

Lesson. This structure had an enclosed area in the central portion of the lower area between the slab-on-grade and the first floor of the home. This enclosed area was conducive to creating high localized velocities. Its location, however, in the central part of the lower area surrounded by a concrete slab for some distance proved in other structures to be not nearly as damaging due to scour as when located near the upstream edge of the slab. Apparently, the tremendous scour that occurred at this structure was aggravated by the enclosed area but was created mostly by the structure's location along the river. Perimeter footings under the slab-on-grade would have greatly reduced the scour even in this apparently bad location. Post embedment depth obviously should have been deeper. For definite protection from this type of damage, piles driven to below the scour depth would have been the ultimate solution.

Looking at tilted structure as a result of scour under the left portion of the structure.

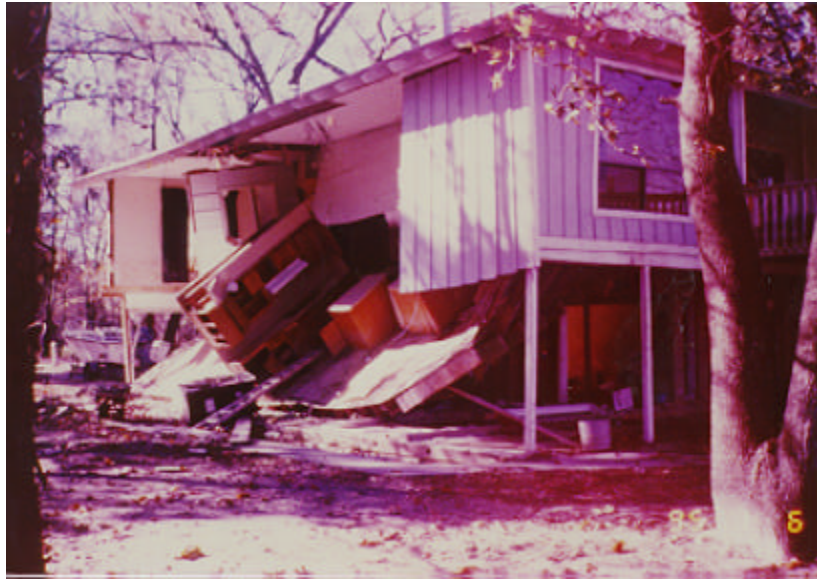
STRUCTURE 67. This single-family home was located about 100 feet from the San Jacinto River. The home was slab-on-grade construction, with the first floor elevated on extended foundation walls and the lower area completely enclosed except for doors and windows. No evidence of any scour was present. One side of the home collapsed, probably because of hydrodynamic force against the extended foundation wall. No reinforcement or grouting was evident in the foundation wall. Flood depth in the area was about 11 feet above grade.

Lesson. This flood proofing system failed for basically two reasons. First, the lower area was completely finished, creating high localized velocities that resulted in extensive damage to the interior. Second, extended foundation walls were used, inappropriately, in high-velocity areas, subjecting the structure to hydrodynamic force.

Looking at the failed structure.

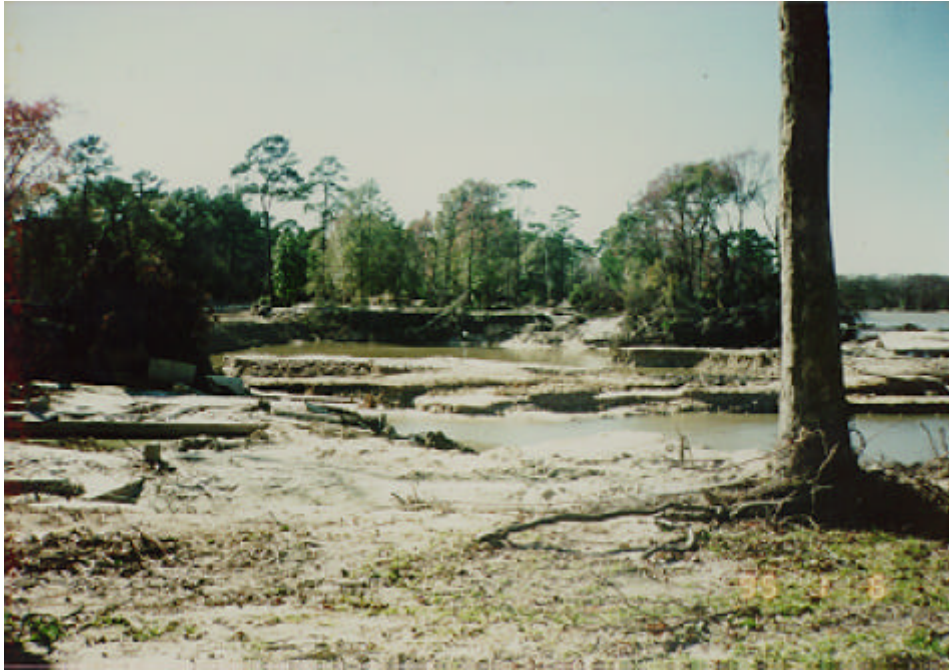
STRUCTURES 68, 69, 70, 71. These structures were all single-family homes. Severe erosion occurred because of deep floodflows at high velocity as floodwater from the San Jacinto River exited the channel to flow overland across a peninsula created by large bends in the river channel. As seen in the photograph, the homes were totally destroyed.

Lesson. No flood proofing system can withstand erosion such as that experienced here. Construction of any type in an area where extremely high velocities can occur is not advised and reflects extremely poor judgment.

Looking across the area previously occupied by these structures.

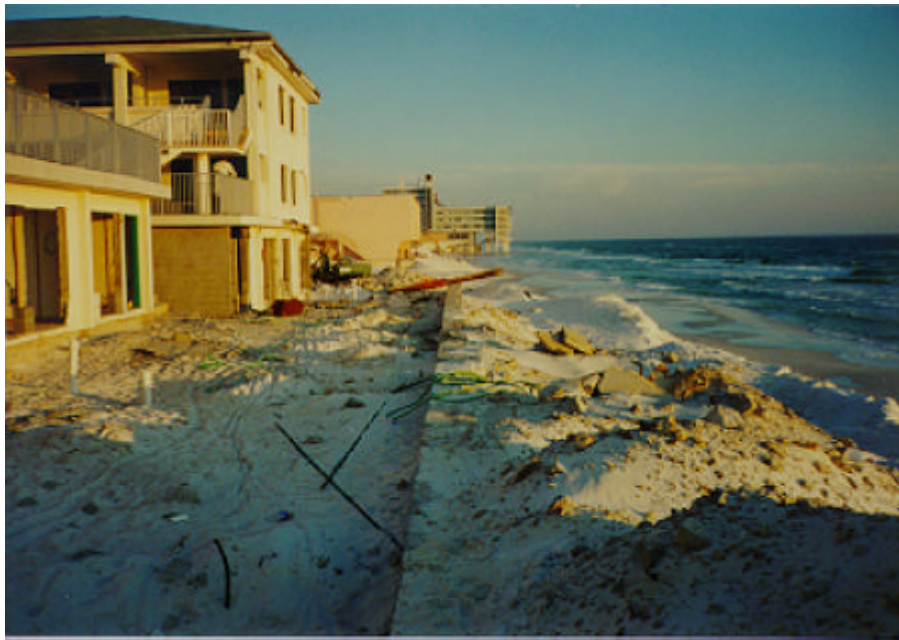
STRUCTURES 72, 73. These structures were located directly on the beach. They were elevated on extended foundation walls made of concrete block with slab-on-grade construction and shallow footings. The lower (at grade) floor was finished with large glass windows facing the ocean. A concrete slab seawall was located between the structures and the ocean. Floodwater damaged the lower at-grade first-floor level. Hydrodynamic force broke the windows. Scour under the slab-on-grade foundation did not occur because of the presence of the seawall.

Lesson. Slab-on-grade construction with shallow footings should not have been used in this location because of the enormous potential for scour. The lower floor should not have been developed because of the great potential for flooding from hurricane force wave runup. These structures, as built, were saved from major structural damage by basically two items. One, the presence of the large plate glass windows on the lower floor broke under wave force, allowing flood damage to occur but reducing the potential for complete wall failure due to hydrodynamic force. Two, the presence of the seawall protected the slab-on-grade foundation from extensive scour, which would have allowed substantial structural failure to occur.

Looking at the slab-on-ground structures and the seawall.

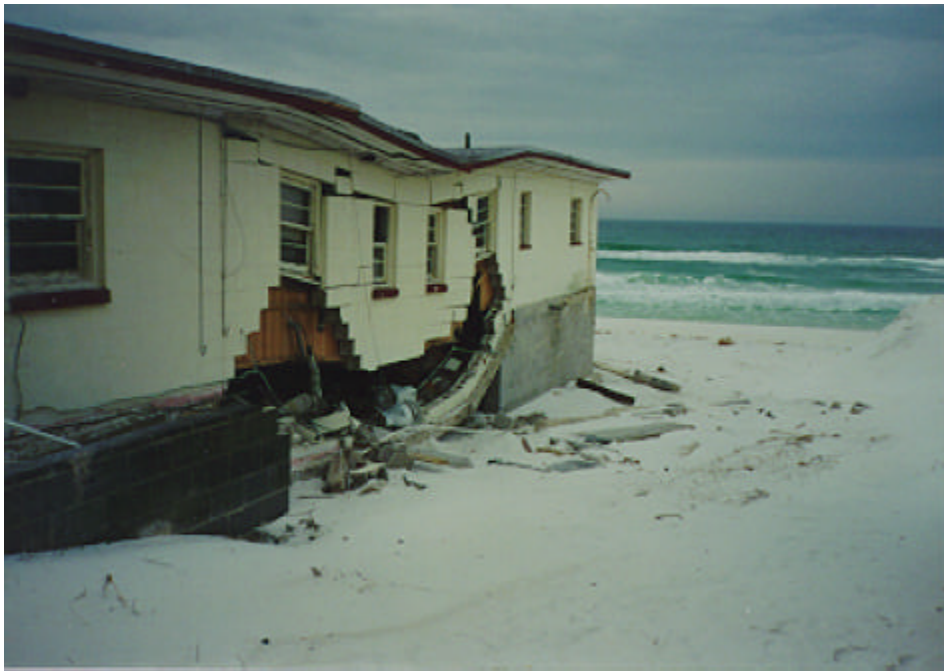
STRUCTURE 74. This structure was elevated on extended foundation walls on shallow footings with the first floor consisting of concrete on sandfill placed within the perimeter formed by the extended foundation walls. The structure was located directly on the beach. Scour undermined the shallow footings along one side of the structure, causing collapse of the extended foundation wall, erosion of the sandfill placed within the perimeter formed by the extended foundation walls, collapse of the concrete floor, and subsequent failure of the concrete block wall and also the roof. Floodwater inundated the first floor.

Lesson. Four basic problems were present with this structure. First, the footings were too shallow, allowing scour to undermine them. Second, extended foundation walls, which are not appropriate for coastal areas subject to hydrodynamic force, were used. In this particular case, failure did not occur because of extended walls, but they made the structure highly susceptible. Third, the concrete slab for the first floor was supported by sandfill. When the perimeter wall failed, erosion of the sandfill occurred, causing the floor to collapse. The floor should have been supported on piles driven to a depth below the potential scour, or the perimeter footings supporting the extended foundation walls should have been constructed to below-scour depth. Fourth, the structure was not elevated enough to prevent floodwater damage. Structures such as this in this location need to be elevated on piles.

Looking at the structure with the beach in the background.

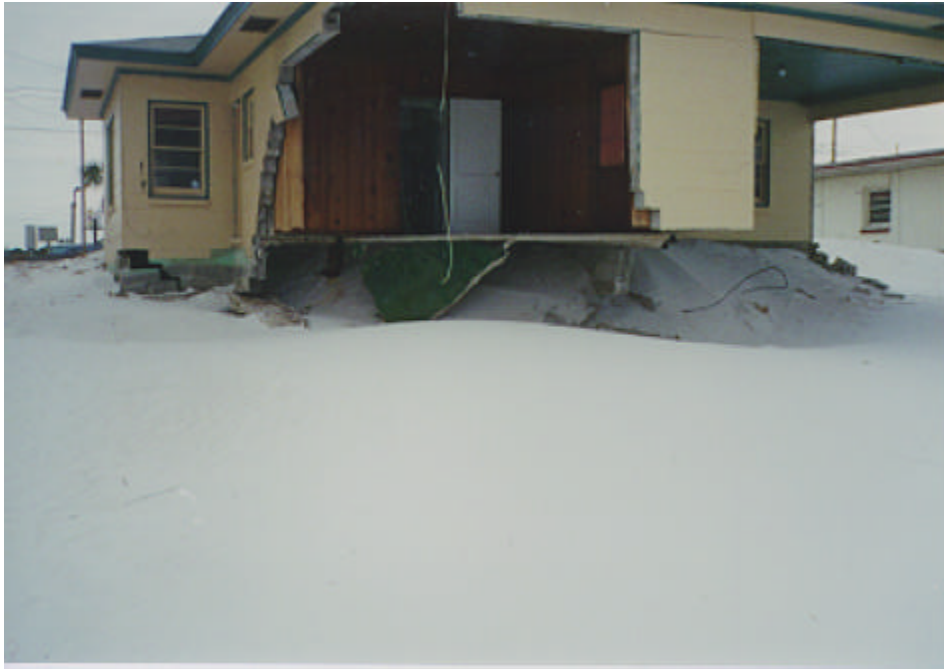
STRUCTURE 75. This structure was very similar in construction to Structure 74, and similar failure occurred. The structure directly fronted the beach, had extended foundation walls on shallow footings with some elevation, and had a first floor slab on sandfill retained by the perimeter extended foundation walls. In the case of Structure 75, the failed wall directly faced the beach; the failed wall on Structure 74 did not. Location of the failed wall may have caused failure of the structure due to both scour under the footings and hydrodynamic force against the extended foundation walls. Erosion of the sandfill allowed failure of the concrete floor slab. Floodwater inundated the first floor.

Lesson. This structure had the same basic four problems as Structure 74--shallow footings, extended foundation walls, concrete slab on sandfill, and inadequate structure elevation. Extended foundation wall failure was due first to scour and then to hydrodynamic force. The roofline on this structure was maintained, unlike that on Structure 74, probably because of the presence (in the middle of the structure) of the concrete block support for the floor and interior wall. This example shows the importance of multiple supports beneath a structure in an area subject to excessive scour. As stated for Structure 74, a structure with extended foundation walls, shallow footings, and a concrete slab on sandfill is definitely not appropriate at this location.

Looking from the beach at the structure.

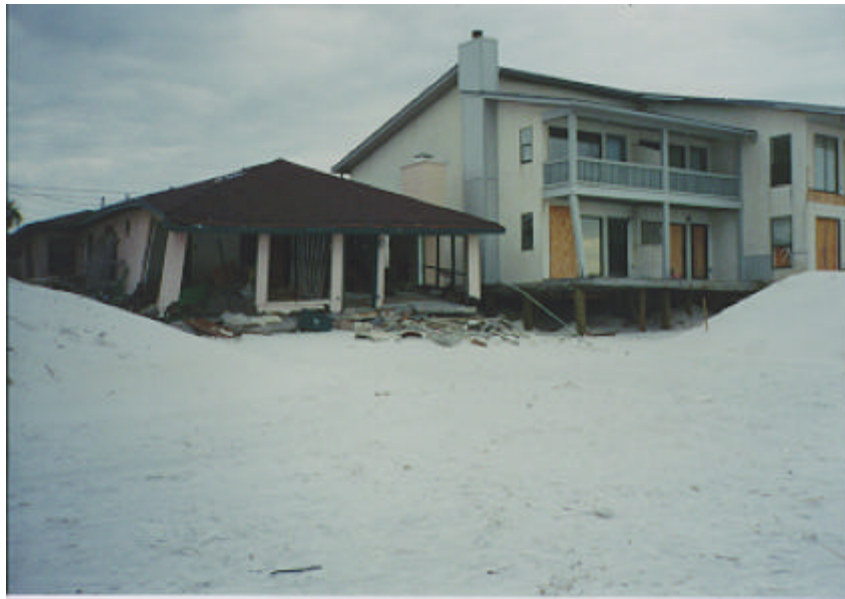
STRUCTURES 77, 78. These structures directly faced the beach. Structure 77 was a one-story residential structure constructed on extended foundation walls. Failure of the footings and extended foundation walls occurred because of the combination of scour and hydrodynamic force. This was followed by first-floor concrete slab failure, wall failure, and roofline failure. Floodwater inundated the first floor. Structure 78 was a two-story residential structure constructed at basically the same first-floor elevation as Structure 77. Structure 78 was supported on wood piles embedded below the scour depth. No structural failure occurred. The first floor was flooded.

Lesson. Comparing Structures 77 and 78, located adjacent to one another, shows the inherent problem with shallow footings, extended foundation walls, and a first-floor concrete slab supported by sandfill. Scour undermined the shallow footings of Structure 77, causing, with hydrodynamic force, the failure of the extended wall foundations. This allowed erosion of the sandfill supporting the first-floor concrete slab and failure. In contrast, Structure 78, supported on piles embedded below scour depth, sustained no structural damage. Both structures were flooded because of inadequate elevation.

Looking at the structure with extended foundation walls on the left and at the structure with a pile support foundation on the right.

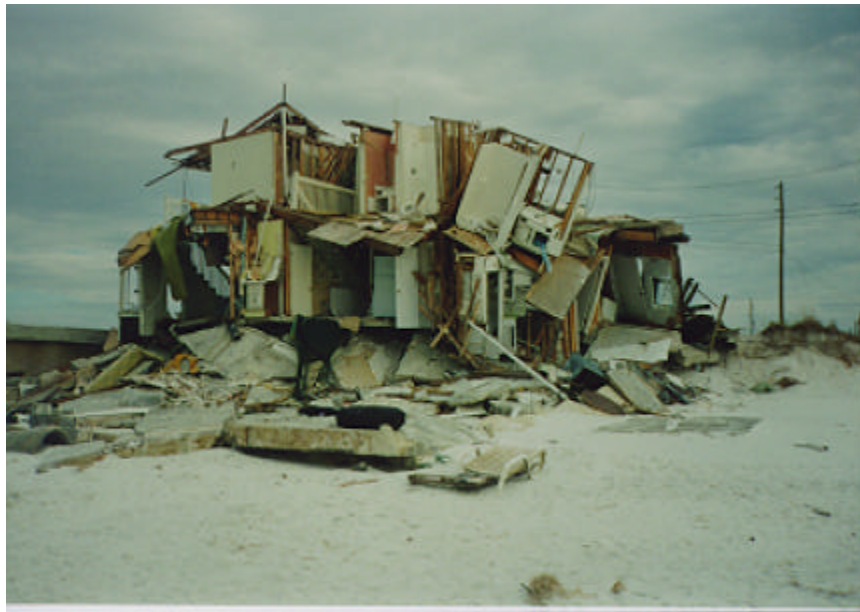
STRUCTURE 79. This structure was a two-story residential structure facing directly toward the beach. It was elevated higher than many along the beachfront. It was supported by extended foundation walls on shallow footings with a concrete slab placed on sandfill for support. Failure occurred because of failure of the footings, walls, and slab. Failure due to tremendous wind damage and hydrodynamic force was also apparent. This structure was totally destroyed.

Lesson. This structure is discussed because it sustained massive damage even though it was elevated as much or more than most structures along this reach of beachfront. Failure probably started to occur because of scour beneath the shallow footings and hydrodynamic force against the extended foundation walls and the structure itself. Erosion of the sandfill caused concrete slab failure. Failure of these foundation elements substantially weakened the structural integrity of the wood-frame structure, allowing wind and hydrodynamic force to cause a near total destruction. A foundation of piles embedded below scour depth, with the piles extending to the roofline for proper structure/footing tie-in, and hurricane fasteners would probably have allowed this structure to sustain minimal damage.

Looking at the totally failed structure from the beach.

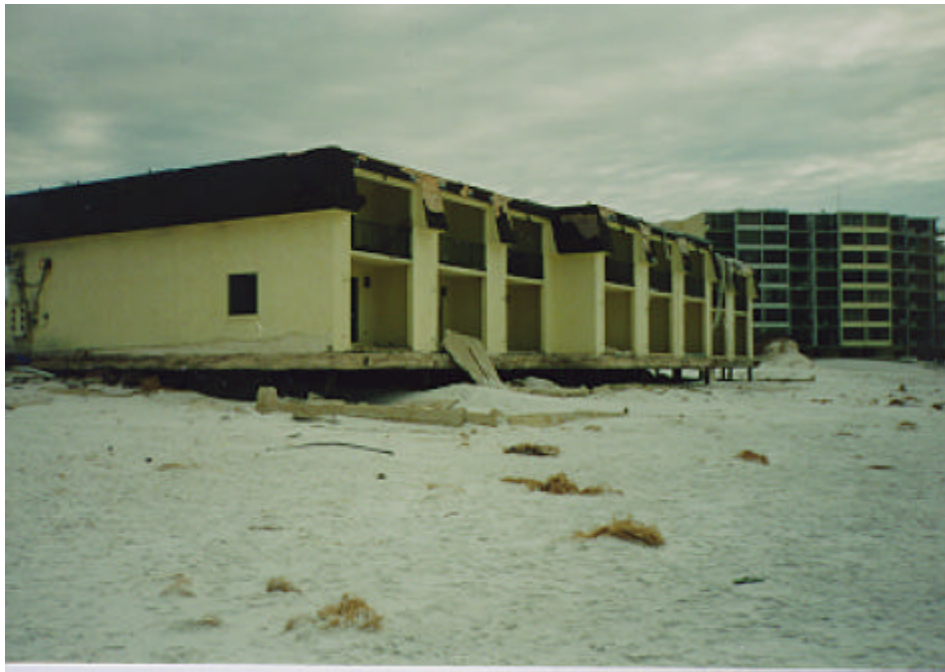
STRUCTURE 80. This structure was a two-story reinforced concrete multifamily dwelling. It was slightly elevated on wood piles. The piles were located beneath the bearing walls of the structure but not under the concrete slab on the first floor. The slab was supported by sand fill. Damage occurred due to erosion of the sandfill beneath the concrete slab, which allowed the concrete slab to drop. The structure was not elevated enough to prevent flood damage. Other than the floor damage, no basic structural damage occurred.

Lesson. The structure performed adequately except for two reasons. One, the structure was not elevated high enough to prevent flooding. Two, the concrete slab on the first floor was supported only by sandfill. When the sand eroded, the floor collapsed. Floor collapse could have been prevented by placing supporting posts beneath the concrete slab or by using rebar to support the floor from the piles located beneath the bearing walls.

Looking at the structure. Note that the building structure did not collapse due to the pile support foundation.

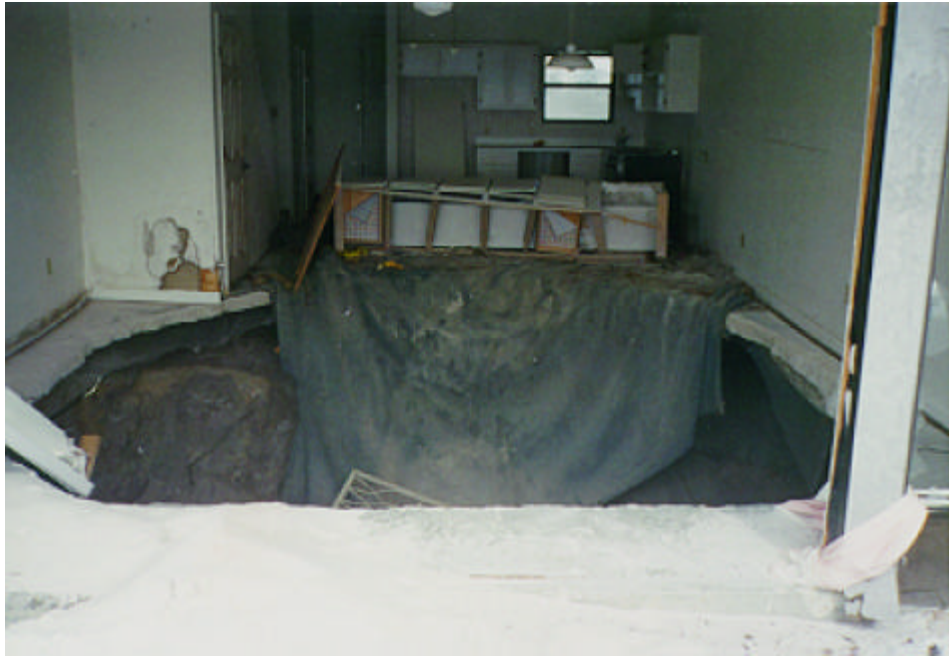
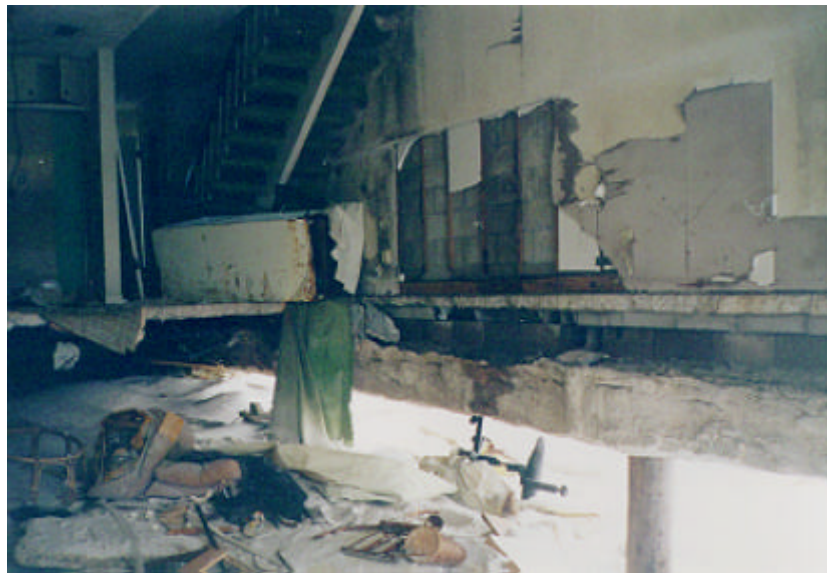
Looking inside the structure at the collapsed floor due to scour of the sand beneath the slab-on-grade floor

Looking inside the structure at the collapsed floor due to scour of the sand beneath the slab-on-grade floor.

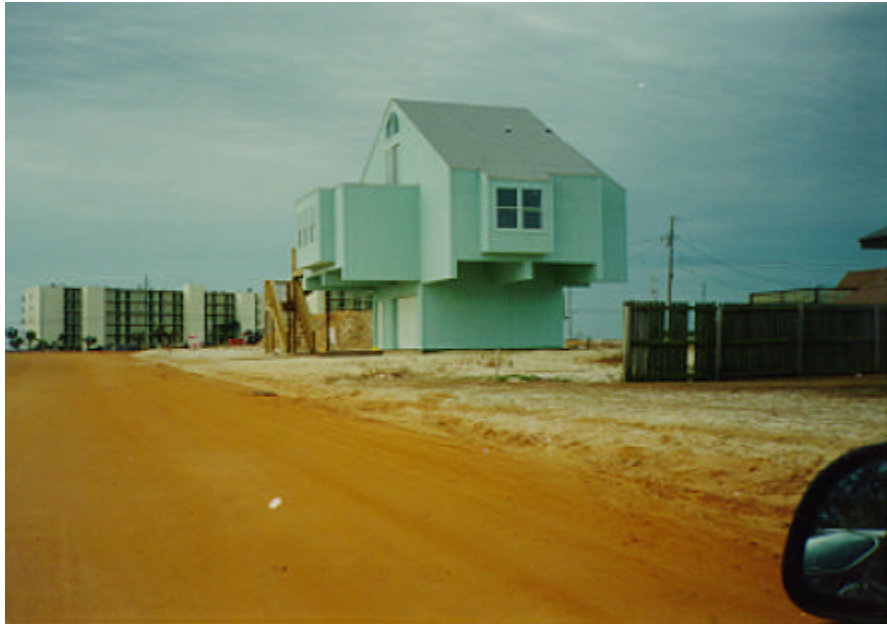
STRUCTURE 81. This residential structure was located about two blocks from the beach. The first-floor living area was well elevated. The lower (at grade) area was fully enclosed with non-breakaway walls and was used as a garage and utility room. Between this structure and the beach was a multistory residential structure. Structure 81 endured the storm forces well.

Lesson. This structure was recently constructed. It had adequate elevation and was constructed to state-of-the-art building codes. Because of its location two blocks from the beach and behind a large multistory building that may have provided some protection from hydrodynamic force, the degree of hazard was lower than had it been located directly on the beach. A note of caution with this structure is the enclosed lower area. This type of enclosed construction, unless the walls are able to break away during a hurricane event, subjects the structure to hydrodynamic force and the potential for foundation scour due to the obstruction to waterflow caused by the enclosed walls at ground level.

Looking at the structure. The beach is in the far background behind the multistory building.

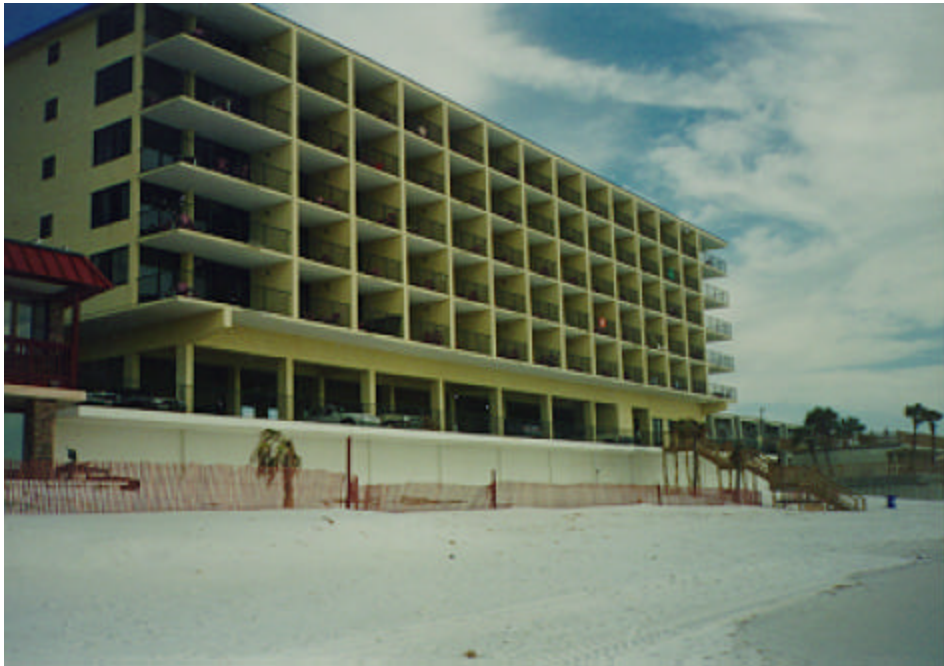
STRUCTURE 82. This multistory residential complex was elevated on reinforced concrete columns that sustained minimal damage. It was located directly facing the beach. The structure's first floor was elevated several feet above beach level and was used for automobile parking. The first habitable floor was two floors above the ocean level. The structure was protected from scour by a concrete wall.

Lesson. This structure was successful for two basic reasons. It had both proper elevation and proper scour/erosion protection. The first damageable floor was well above the flood level since it was two floors above the ocean level. The first floor was occupied by automobiles which can easily be moved to a nonhazard area with proper warning time. Scour did not pose a problem because of the wall and the proper column embedment depth.

Looking from the beach at the structure.

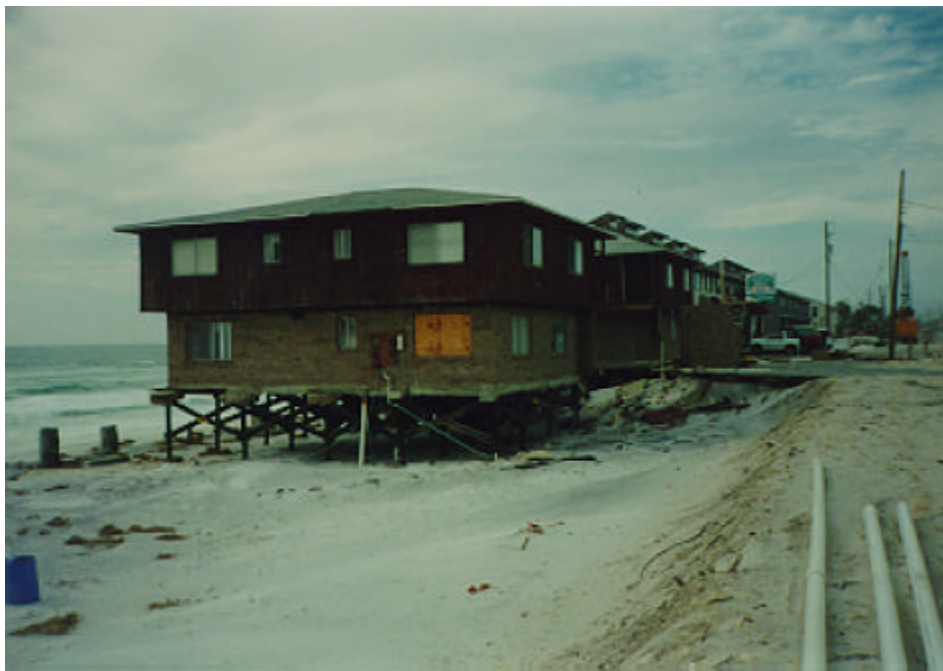
STRUCTURE 83. This structure was a motel complex consisting of two buildings with two habitable stories each. A concrete swimming pool was located between the two buildings. The structures were elevated above the beach but not enough to prevent first-floor flooding. The structure directly faced the beach. Support was provided by 8-inch wooden piles approximately 9 feet on center. These piles were braced by wooden “x” bracing. The floor of each building was a concrete

slab placed on sandfill. From visual inspection, it could not be determined if rebar was present in the concrete slab. Severe scour occurred around and beneath the buildings to the extent that the buildings, which prior to the event appeared to be “at grade,” were, after the event, elevated about 5 feet above the grade after scour. The concrete swimming pool, which was supported on sandfill, had dropped several feet from its pre-event elevation because of scour of the sandfill

Lesson. Severe scour occurred around and under these structures during the event. The wood piles appeared to be improperly sized, since some were visibly leaning under the weight of the buildings without sandfill support. The “x” bracing on the piles may have saved the building from collapsing. This shows the need not only for proper embedment depth of posts or piles but also for proper size of posts or piles for needed strength. In this case, where sandfill appears to have been factored in as a part of the building support/stability system, a protection wall around the building that could have withstood the scour hazard and hydrodynamic force should have been built. The most proper design, however, would have been to elevate the buildings on larger diameter piles that were completely independent of sandfill for added support to the buildings.

Looking at the structure and beach. Prior to the event, the “grade” elevation at the far right extended toward the beach and under the structure.

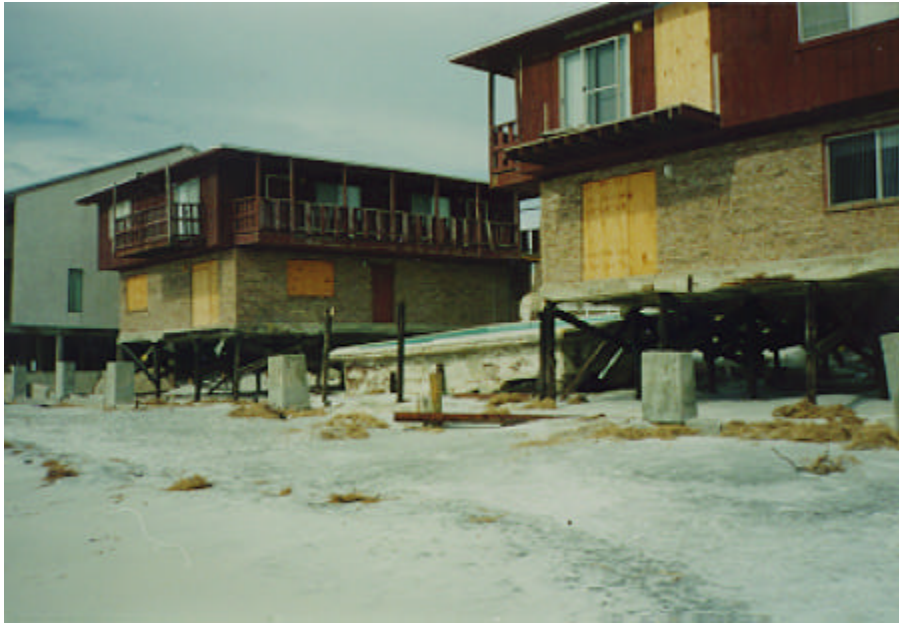
Looking from the beach at the structure. Note the collapsed swimming pool between the structures.

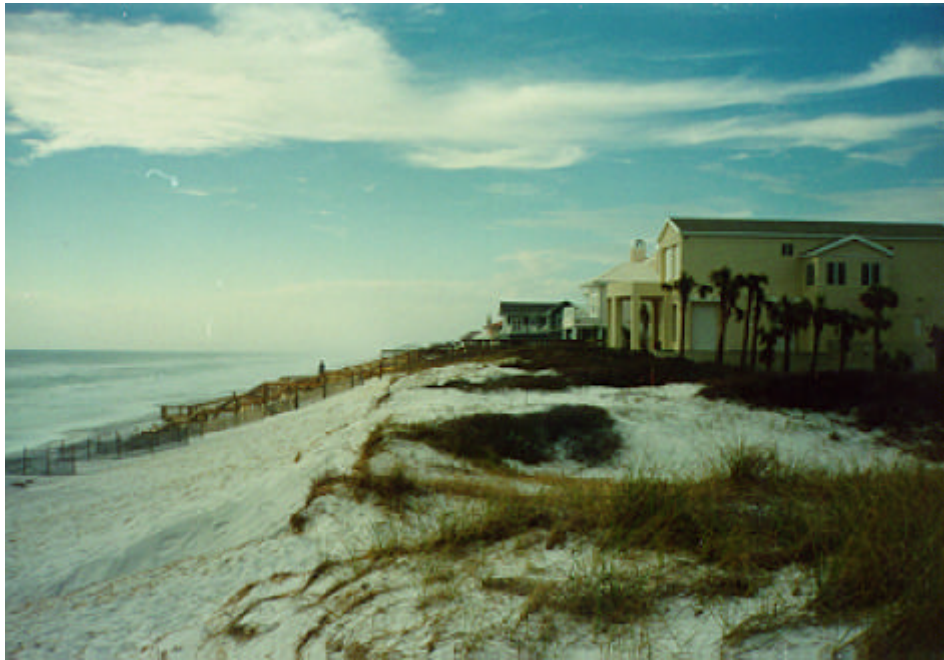
STRUCTURE 84. This structure number represents structures that directly faced the beach but were set back a considerable distance, were elevated relative to sea level, and have been protected by a sand dune with natural vegetation. In this case, the dune appeared to be natural but could just as well have been manmade. The combination of higher elevation, greater distance from the beach, and/or existence of a natural dune provided good protection to these structures.

Lesson. “Conventional” construction techniques in the structure itself are often very adequate to mitigate hazards from floods, erosion, and hydrodynamic force if other nonstructure-related techniques are employed. In this case, constructing structures on higher ground is a large step toward hazard mitigation in the form of reduced flood damages. A large setback allows room for either a natural or a manmade dune to be located between the ocean and the structure. This can diminish or eliminate hydrodynamic force on the structure and the potential for scour at the structure.

Looking along the beach at the structure and the dune. Note the structure elevation and the dune protection.

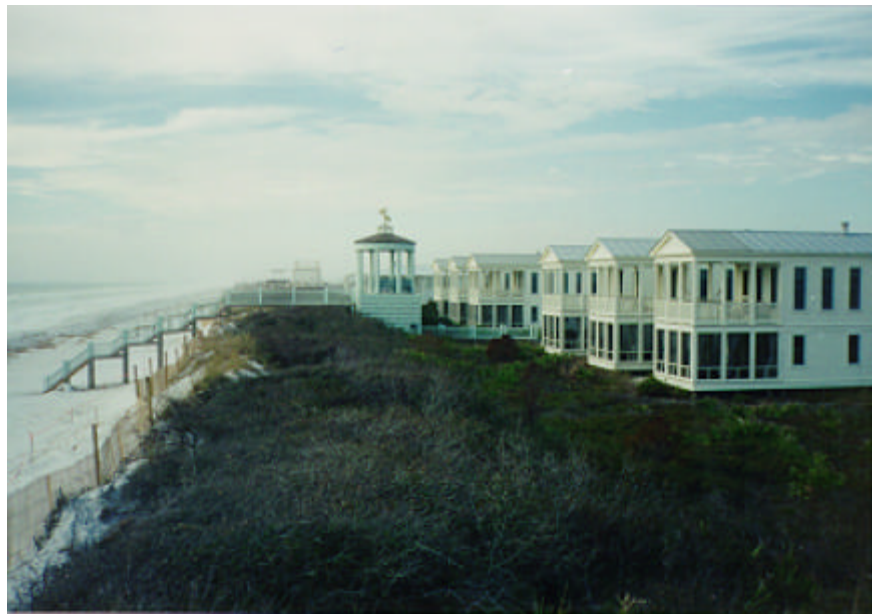
Looking along the beach at the structures and the dune. Note these structures are not elevated as high as those in the above photograph but the dune has much more vegetation.

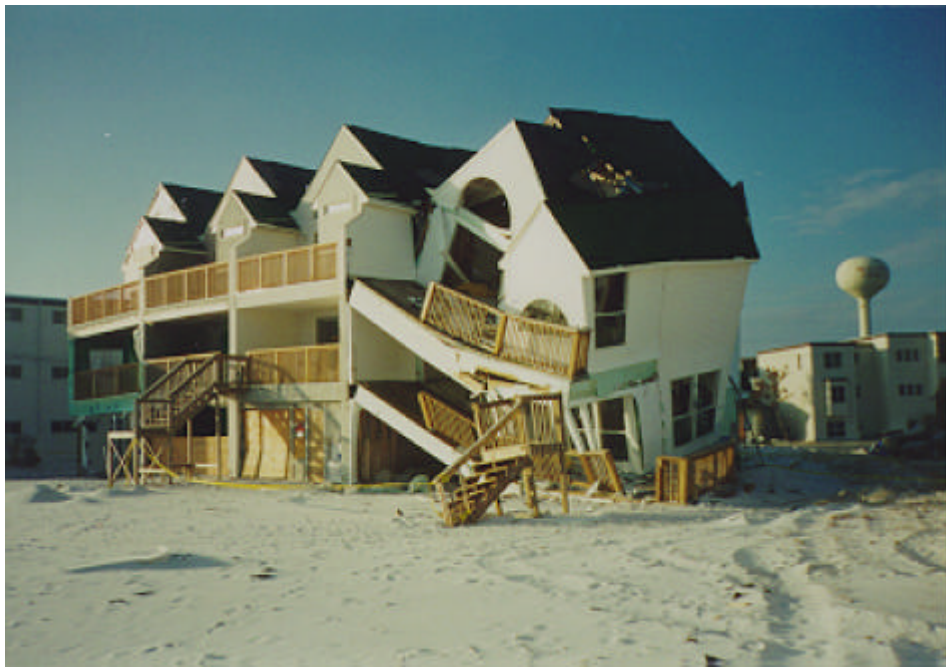
STRUCTURE 85. This structure, which was constructed on a barrier island, faced the beach. The structure was a three-story wood-frame building with the first floor elevated by wood-frame construction on shallow footings. Very high flood velocities were experienced in this area as floodwater flowed across the barrier island. Floodwater depths of about 4.5 feet were directly impinging on the structure. Localized scour occurred, which undermined the shallow foundation and caused one-fourth of the structure to collapse.

Lesson. Two basic factors caused the collapse of one-fourth of the structure. First, the construction on the barrier island placed the structure in jeopardy due to high-velocity floodwater, creating both a hydrodynamic force hazard and a scour hazard. Construction in areas such as this should be avoided. Second, the structure foundation that was situated in sand should have been much deeper to resist the forces of erosion caused by the high velocities and compounded by the obstructive nature of the structure.

Looking at the structure from the beach.

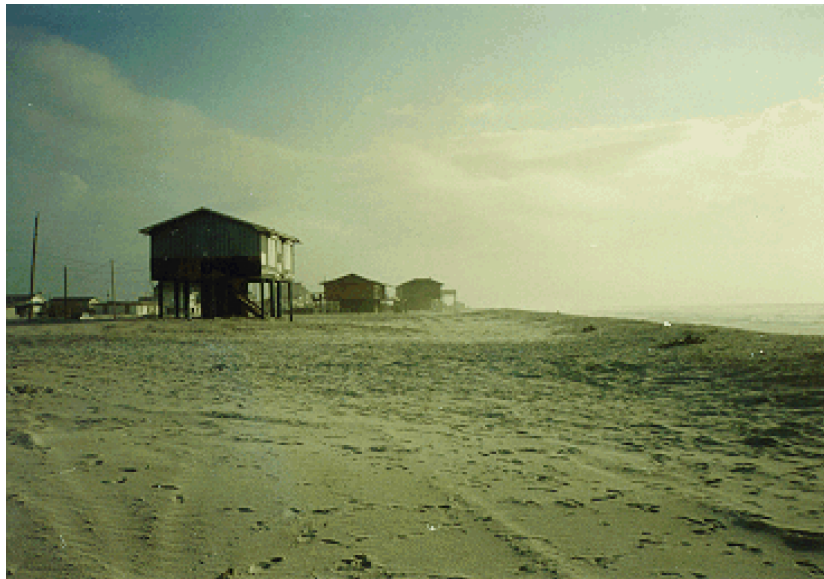
Lesson. This structure survived well in this event. However, the enclosed lower area could have created a problem due to the obstructive effect of the floodwater creating hydrodynamic force against the enclosed area and higher localized velocities as floodwater flowed around the enclosed area. This effect could cause excessive localized scour to depths not anticipated in sand, undermining pile supports and causing failure. It is best in warm climates, such as occurs in Florida, to have lower level storage areas enclosed with “jail-type” spaced bar construction so floodwater can flow through, eliminating hydrodynamic force and scour potential.

Looking along the beach at the structure.

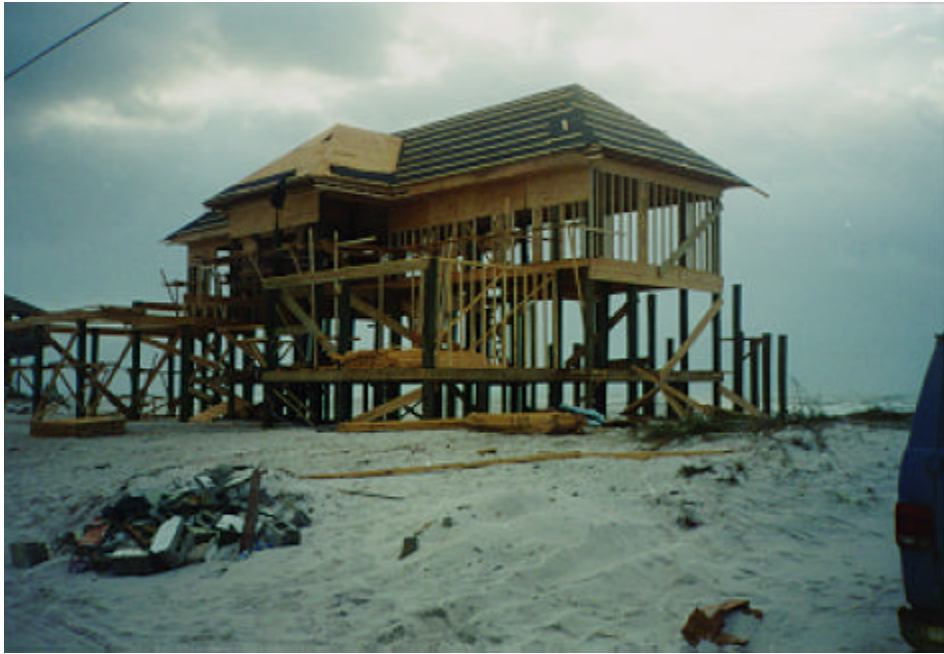
Lesson. This structure was designed to accommodate hurricane hazards from wind,

flooding, and scour. One possible weakness was observed at the intersection of the main floor with the wooden piles. The wooden piles were notched to accommodate a resting place for the main floor sills to the extent that the 12-inch-diameter wooden piles were reduced in diameter to approximately 6 inches. This weakens the effectiveness of the piles' ability to bond the entire structure together in terms of the ability to withstand hurricane force winds.

Looking at the structure with the beach in the background.

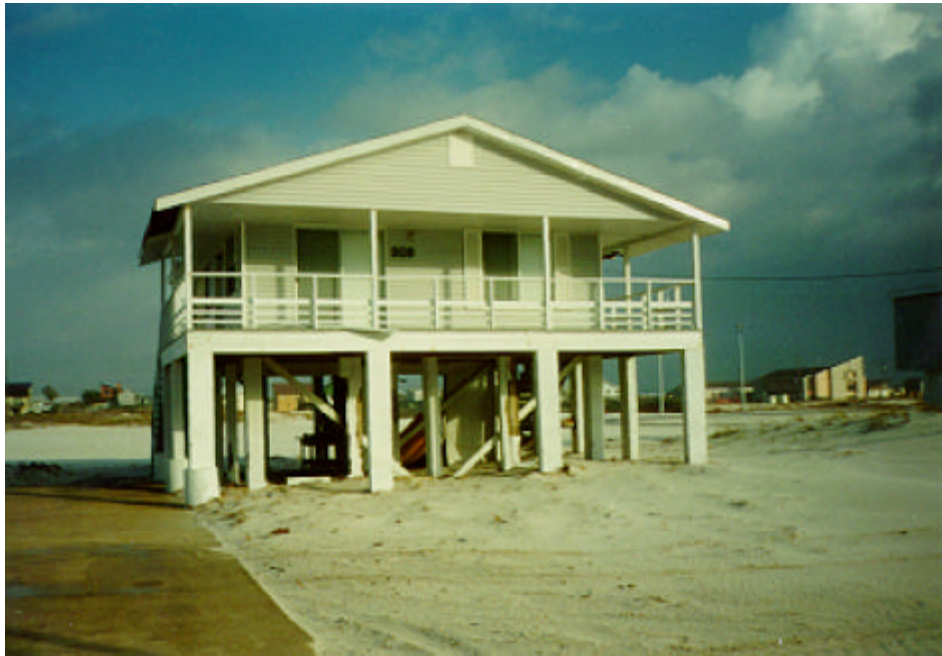
STRUCTURE 88. This structure was a single-family, wood-frame home elevated on columns made of concrete block with a one-half-inch rebar grouted into each hole of the concrete block. This made a reinforced concrete block column for use in elevating the structure about 8 feet above grade. The structure was about 300 feet from the beach on the landward side of a beachfront street. The structure survived the event well, except for the reinforced concrete block columns, which sustained severe cracking apparently from the torsion effect of the hurricane force wind against the structure. No “x” bracing was used between the columns. The columns appeared to be close to failure.

Lesson. Reinforced concrete block columns of this design are not appropriate in coastal areas where high wind forces occur against a structure. The concrete block columns should have contained more rebar in order to provide rigid strength against the hurricane force winds. The best alternative is to use piles that have the ability to resist this type of force without becoming damaged.

Looking at the structure.
